Re: Bicentennial Seawall – Hampton, New Hampshire

**Bicentennial Park Seawall: Interim Stabilization Options
Town of Hampton**

Bicentennial Park Seawall, Hampton, NH – Test Pit Logs

Re: Hampton Sea Wall

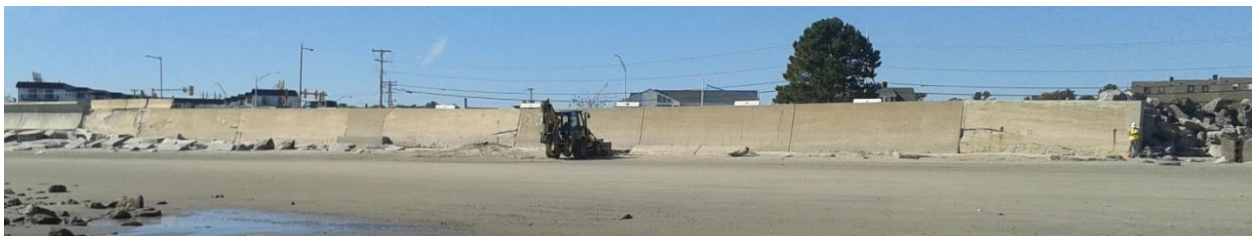
Photo 1: Seawall on October 11, 2016

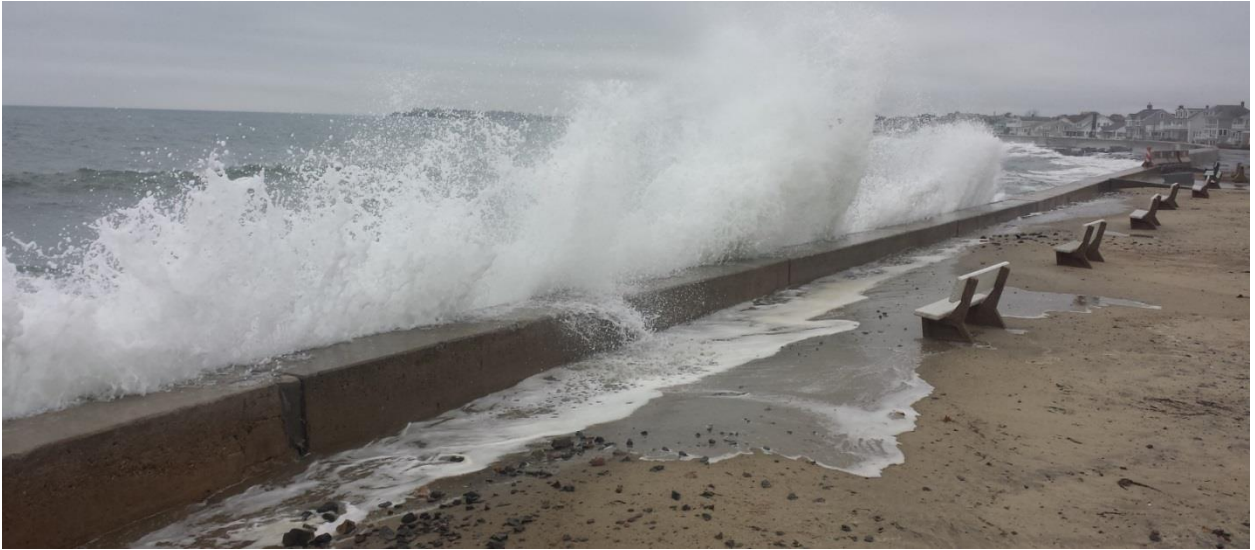
Very high tides with waves breaking over the seawall did occur around October 18 and November 16, which likely caused some beach scour at the seawall, however these were low wind conditions and storm events may increase beach scour.

Photo 2: Seawall wave overtopping on November 16, 2016

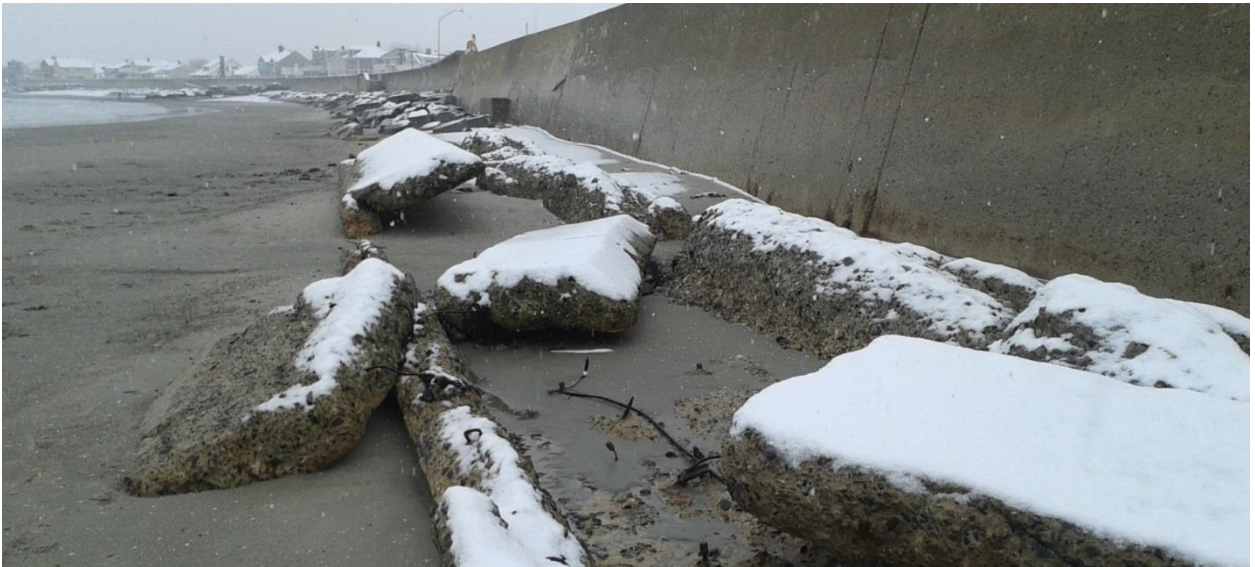
A site visit on December 5, 2016 showed a lower beach level by about one foot, with additional stone revetment and concrete debris exposed. Exposed seawall height was measured along the wall and comparison to archive design details and prior test pit measurements indicates seawall embedment has been reduced to generally about one foot.

Photo 3: Seawall and beach on December 5, 2016

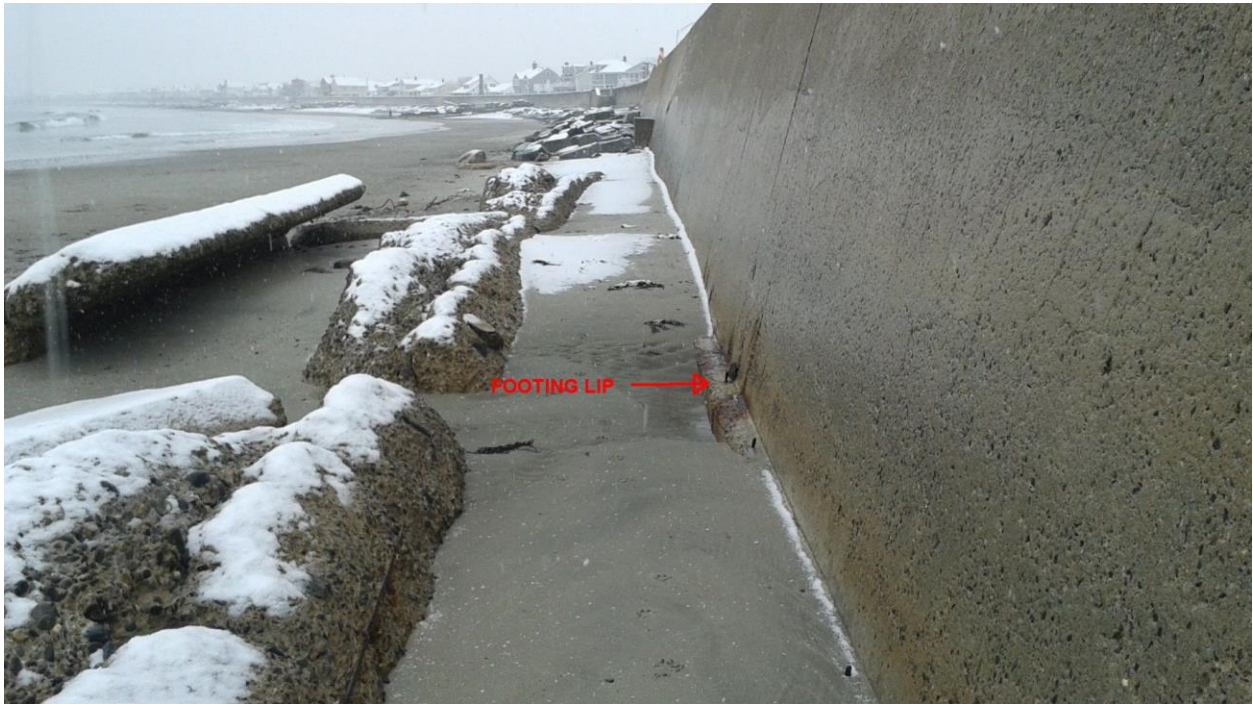
Photo 4: Seawall and beach on December 5, 2016 with footing exposed and typical seawall embedment of about one foot based on exposed wall height measurements

With the lower level of the beach sand, concrete debris on the beach is visible and appears to be a failed length of the prior seawall over three panels of wall with the 1950's repair overlay visible in the concrete debris on the beach. These observations suggest approximately 100 linear feet of seawall previously collapsed onto the beach after the 1950's repairs and was replaced prior to the survey benchmark being installed about 1980 (benchmark data sheet).

Interim stabilization of the seawall is recommended with at least a minimal stone revetment repair adding armor stone to the revetment, extending out from the existing seawall face 16 feet with at least 5-ton armor stone to buttress the seawall. This stone would be reset and reused with any of the recommended seawall repair or replacement alternatives and it would be part of the longer term fix. The stone is a natural material consistent with the existing shoreline and adjacent state seawall and revetment. The stone revetment would be set in a step-like manner to reduce wave runup, and the porous nature of the stone revetment will help reduce wave reflection and beach scour.

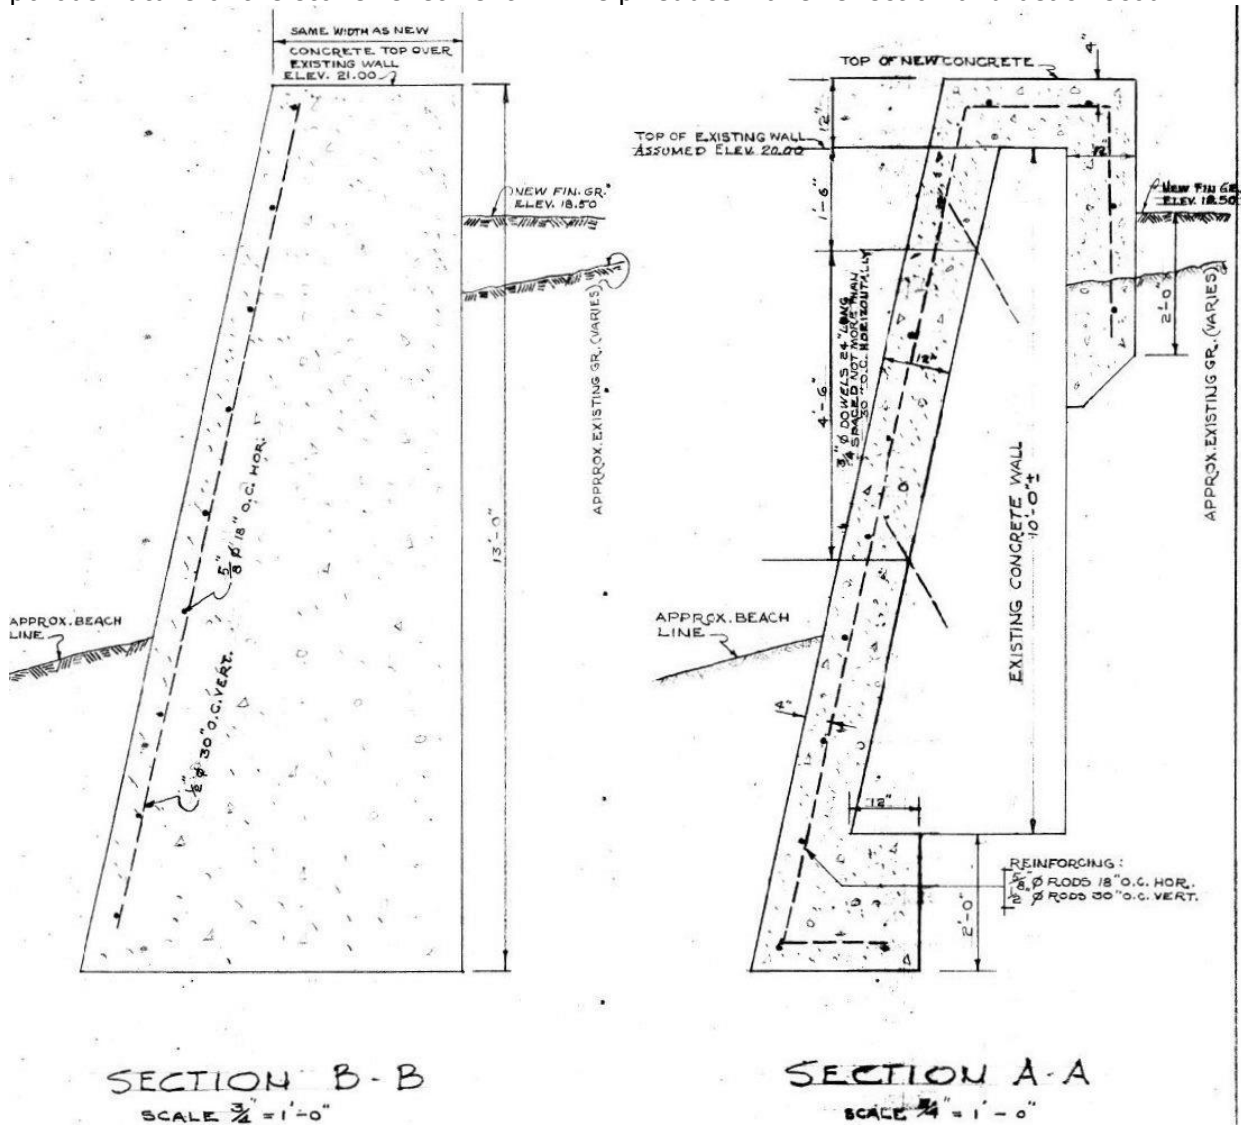
We reviewed the June 13, 1950 archive drawing from the US Coast Guard, titled *Seawall Repairs*, which indicates the seawall has no real footing. The seawall repair completed by the Coast Guard circa 1950 indicates the seawall cross section is narrow and comprised of 1950's concrete over an older smaller concrete seawall that currently is in very poor condition (see seawall concrete test report).

Archive seawall details from 1950 USCG drawing

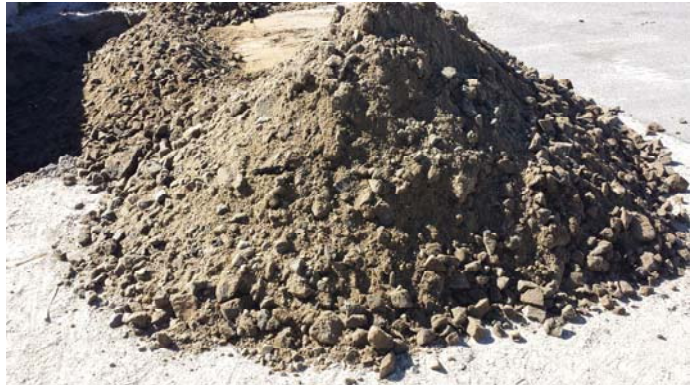
Test Pit #1 is located to the southwestern end of the seawall, between the seawall and the asphalt parking area. This test pit was dug to attempt to locate a return wall that was shown to be removed on a plan from 1950 by the U.S. Coast Guard. The test pit was dug to approximately 6' and no return wall was found, confirming removal shown on the U.S. Coast Guard plan. The backfill was noticed to be a structural gravel backfill consisting of small 3"-4" sub-angular cobbles and fine to coarse grained sand and gravel (see Figure 1). This is consistent with the removal of an old section of wall, and backfilling the area that had previously been on the front side of the wall.

Figure 1: Test Pit #1 excavated backfill

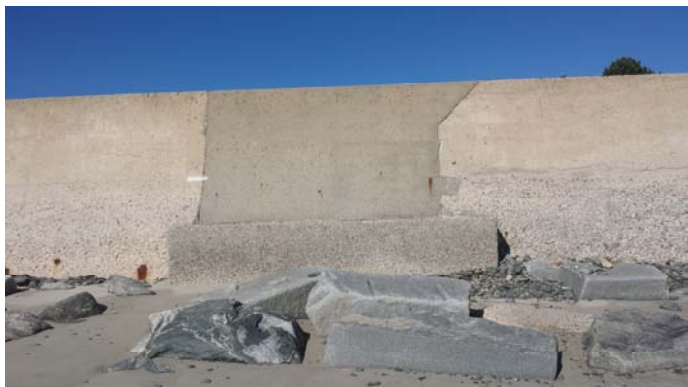
Test pit #2 was dug to the northeast of the angled buttress wall that extends directly to the west of the inshore face of the seawall. This test pit was dug to attempt to locate an old concrete ramp that was used by the Coast Guard station that previously at this site. This ramp is shown on a plan from the U.S. Coast Guard dated 1950 along with two retaining walls on either side of the ramp. The test pit was dug to approximately 9' and the old concrete ramp and the second retaining wall were not found. A small 6" lip was

Figure 2: Old ramp footing and new concrete

observed 84" from the top of the wall which indicates the location of the removed ramp. This elevation is consistent with the footing that can be seen on the front side of the seawall and the newer looking concrete that filled in the gap made by the ramp (see Figure 2). It is

unclear why one of the retaining walls was left in place. The excavated material was a gray fine to coarse sand.

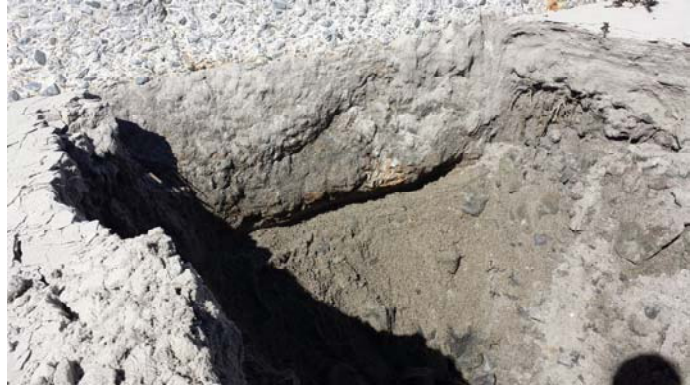
Test Pit #3 is located on the ocean side of the seawall, to the northeast of the location of the old ramp. The test pit was dug until the toe of the seawall was uncovered at 22" below beach level, then, the soil under the seawall was dug out by hand to a point approximately 18" towards the back of the seawall. According to the U.S. Coast Guard plan form 1950, the overlay concrete extends away from the toe of the seawall towards land and has a small return.

Figure 3: Sediment layers in Test Pit #3

This was not observed in this test pit, but the U.S. Coast Guard plan is not clear on the distance this return extends. It is possible that it exists, just further than the 18" excavated. This test pit uncovered a 9" layer of gray beach sand on top of a layer of recent seaweed, indicating recent sediment transport resulting in 9" of sand accumulating in front of the wall (see Figure 3).

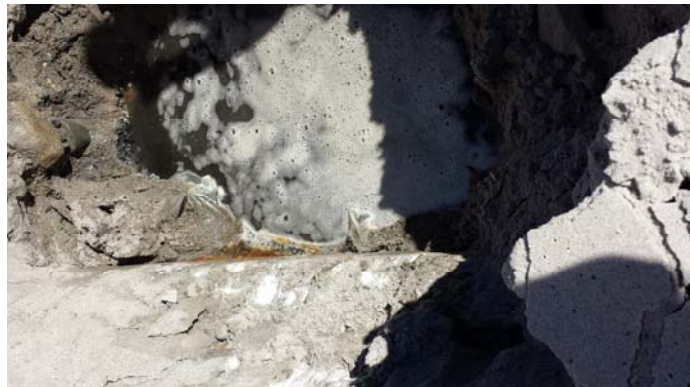
Test Pit #4 was dug on the ocean side of the seawall, further to the northeast than Test Pit #3. The toe of the wall was observed at 36" depth. In addition, plastic sheeting was observed (see Figure 4) indicating a possible newer concrete repair.

Figure 4: Plastic sheeting in Test Pit #4

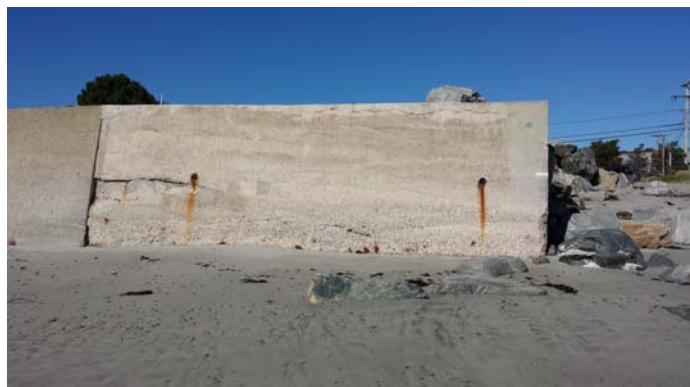
Test Pit #5 was dug on the ocean side of the seawall, towards the northeastern end. The test pit was dug at a transition between the overlay section and the new wall section according to the U.S. Coast Guard plan from 1950 (see Figure 5). The test pit was dug to approximately 8', with the toe of the seawall observed at 24" depth. Gray fine to coarse sand similar to the sand observed in other test pits was observed for the entire 8' depth.

Figure 5: Overlay section/new wall section transition

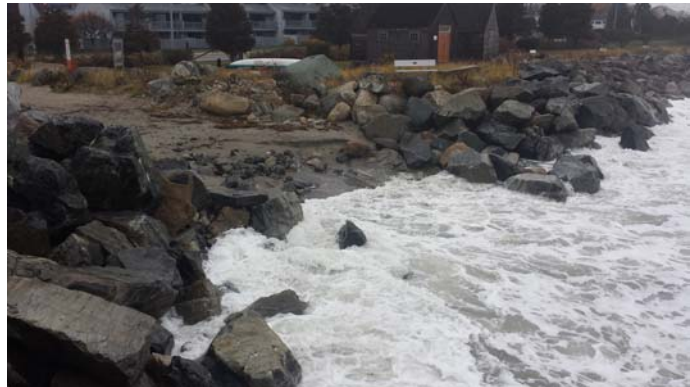
Test Pit #8 was dug in the beach access ramp to the northeast of the site. This test pit was dug to observe the underlying materials and to see if there had been any armor stones placed under the beach sand. The largest stones observed were small to medium cobbles, no bigger than 6", under a 6" layer of beach sand and assess wave erosion potential. In a subsequent site visit, the area of Test Pit #8 had been scoured by wave action and 12"-18" rounded boulders were observed (see Figure 6). However, these stones did not seem to be placed as armoring stones, rather they seemed to be chinking stones used in the revetment to either side of the ramp that had migrated into the ramp section.

Figure 6: Area of Test Pit #8 after wave scour

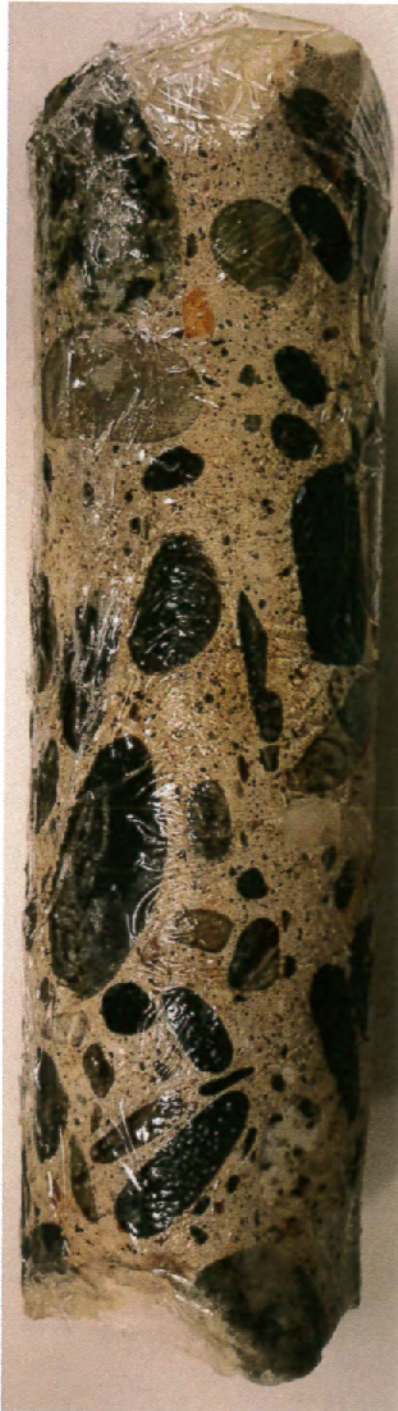
Two cores and various pieces of core borings were pickup at the offices of Tighe & Bond located at 177 Corporate Drive, Portsmouth, New Hampshire. Figure 1 shows the original concrete after it was coated with a low viscosity clear epoxy and wrapped in plastic wrap to assure penetration. This core was impregnated with epoxy to assure it would hold together when cut and polished for laboratory investigation. Several miscellaneous pieces of the old concrete are shown in Figure 2. Figure 3 shows a core with both the old concrete on the left end as well as the overlay concrete on the right side.

Figure 1 Hampton Sea Wall original concrete core after coated with clear low viscosity Epoxy

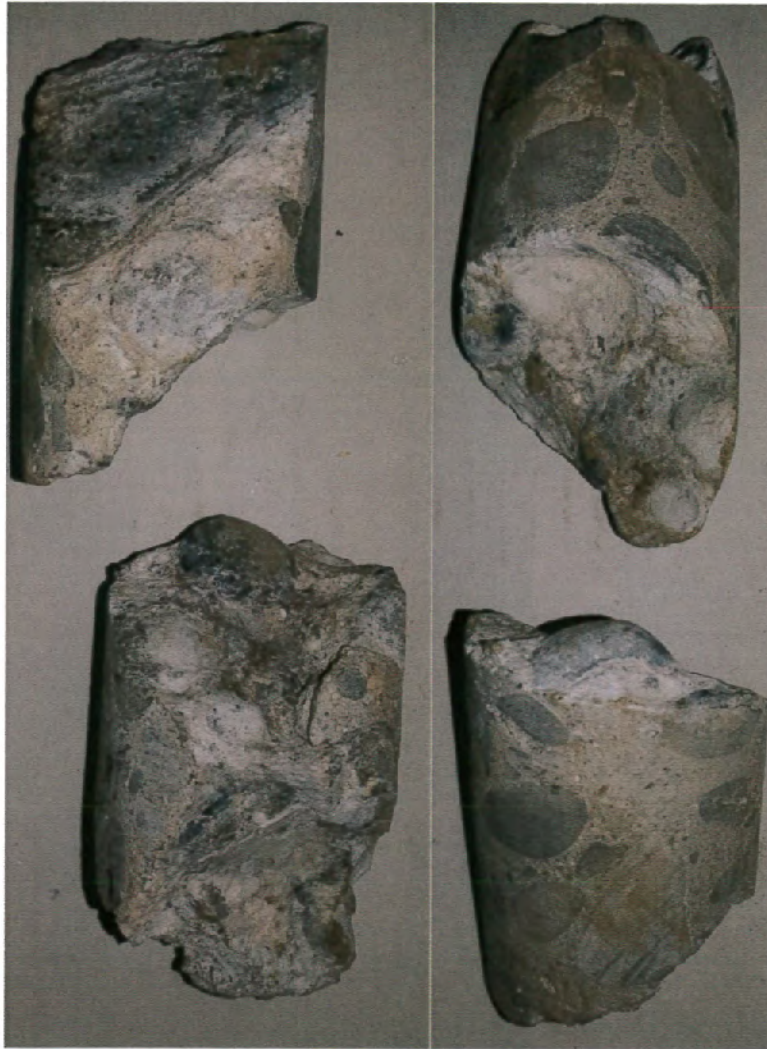
Figure 2 Hampton Sea Wall original concrete core pieces

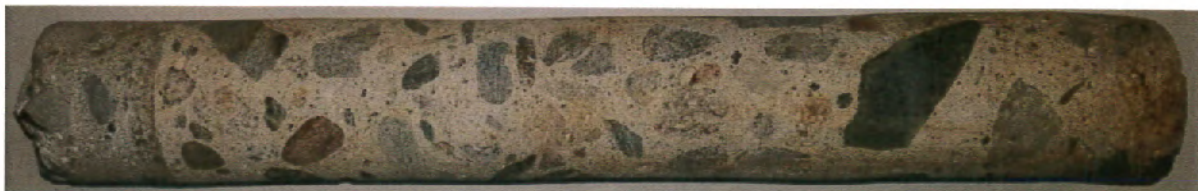
Figure 3 Hampton Sea Wall concrete core with old concrete (left side) and overlay concrete (right)

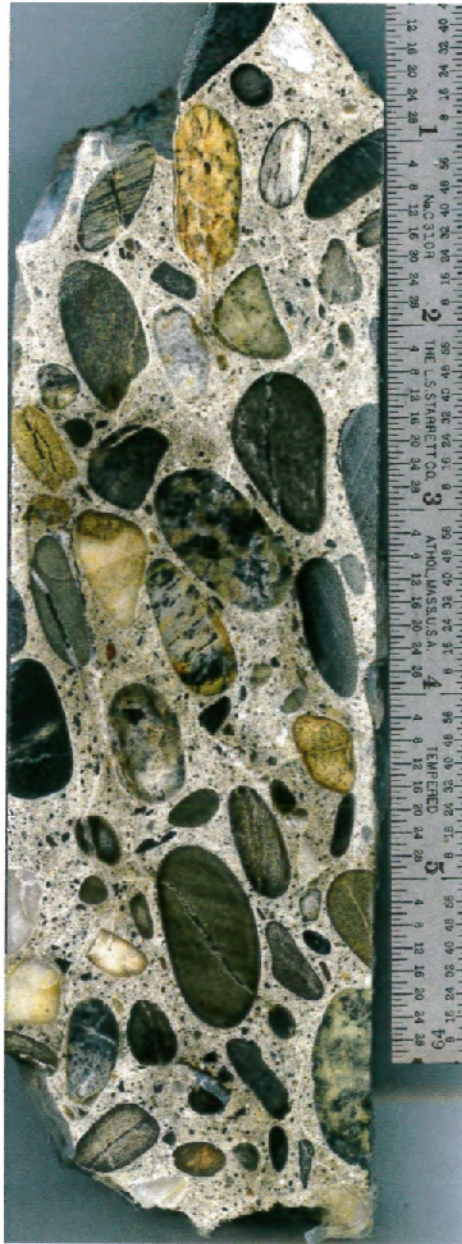
The epoxied core of the original concrete was cut and polished for viewing under a binocular microscope. Figure 4 shows the polished section. The aggregate is a gravel from a glacial deposit as noted by the rounded particles. The aggregates are mostly igneous and very siliceous

in nature. The maximum aggregate size is approximately 1". The aggregate size distribution is well distributed and as placed the concrete appears to have been of reasonable quality well compacted with no signs of bleeding. There are significant cracking throughout the section with massive deposits of gel within the paste as well as the aggregate. Several aggregate particles are literally jacked apart showing massive expansion has occurred within the concrete. Such expansion is consistent with Alkali Silica Reaction (ASR). Several reaction rims, often related to the leaching of Silica from the aggregates at the paste aggregate interface, are visible. This is another potential sign of ASR. This concrete is extremely distressed.

Figure 4 Hampton Sea Wall original concrete cut and polished section

It is recommended any proposed repair of the Hampton Sea Wall not structurally rely on the use of the old ASR concrete. Trying to bond to or structurally attach to this ASR concrete is not recommended. On the other hand, enveloping the old concrete with an independent structural skin is highly recommended as a viable method of economically extending the life of the Hampton Sea Wall.

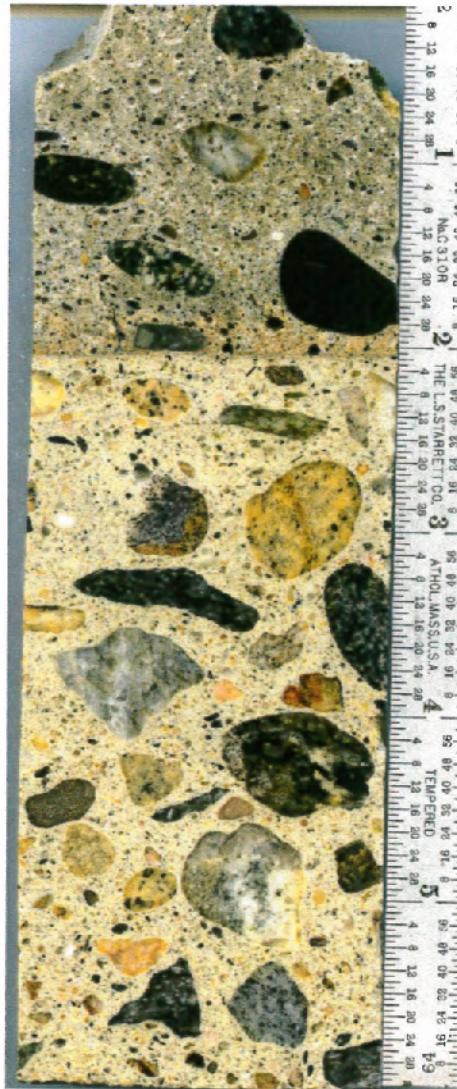
The old and original concrete interface is shown on Figure 5. The older concrete is on the top of the polished section. There are no apparent signs of ASR in the older concrete or the overlay. It was surprising that the bond between the old and overlay concrete was intact! This may be an anomaly and exists intact only at this particular location. It is likely the stress caused by expansion of the old ASR concrete was dissipated by adjacent cracks. The overlay concrete is also a glacial aggregate but has been processed by crushing as noted by its high angularity. The mineralogy appears also to be igneous in nature and siliceous as well. The maximum aggregate size is approximately ¾". The aggregate size distribution is reasonably good. There are no tell tail observations indicating the concrete was not of good quality when placed.

Figure 5 Hampton Sea Wall cut and polished section showing old (top) and overlay concrete (bottom)

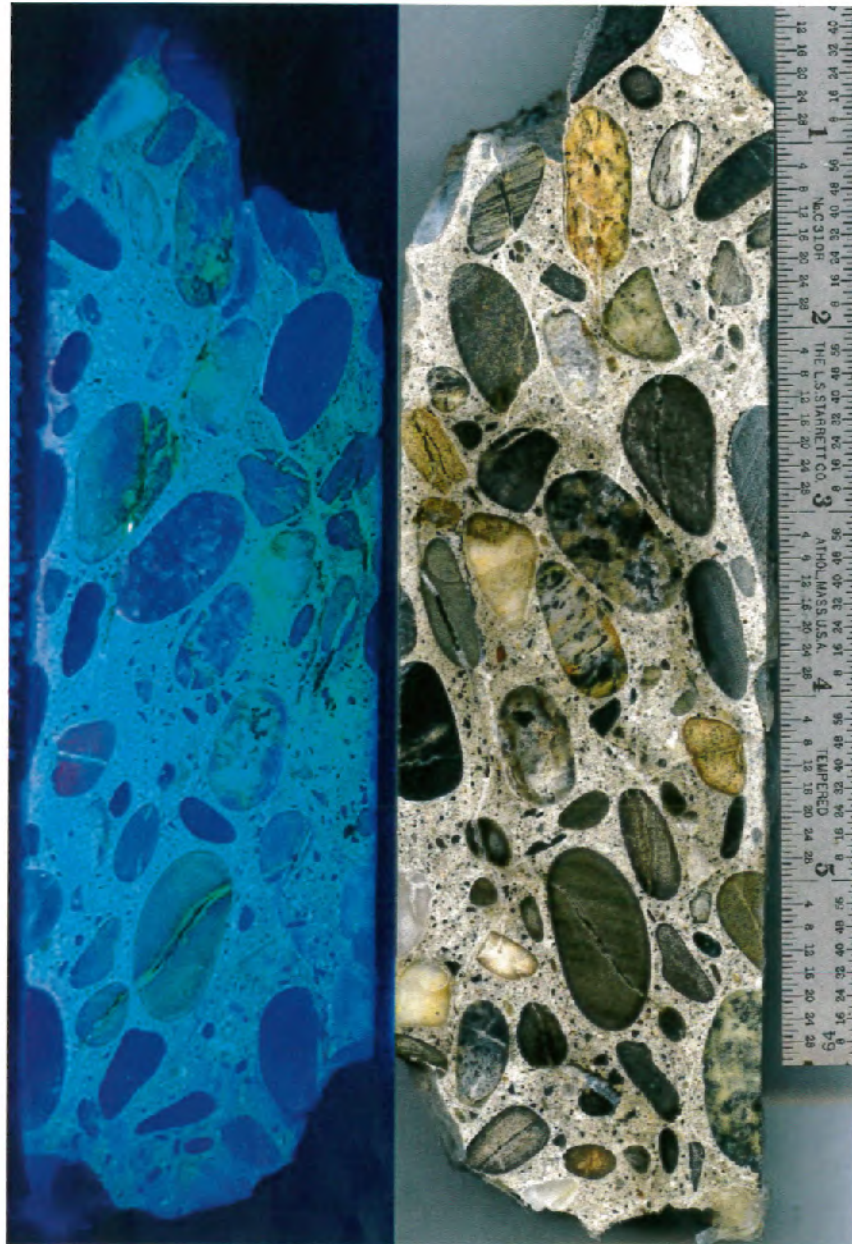
Figure 6 shows the cut section coated with a solution of Uranyl Acetate Dihydrate under ultraviolet light (see left photograph). For comparison the polished mirror image is shown on

the right side of the photographs. The greenish-yellow glow shows the presence of ASR gel. The gel appears to be everywhere throughout the section. The gel is apparent between cracked aggregate particles and within the paste. This is a classic case of ASR.

Figure 6 Hampton Sea Wall original unpolished concrete coated with Uranyl Acetate and under Ultraviolet Light (see left side). Right side is polished mirror image under normal light
